JD-87-GP07

CONTRACT NO: DAAK70-87-C-0061

FINAL REPORT

SDMHE DRIVELINE BENCHTEST

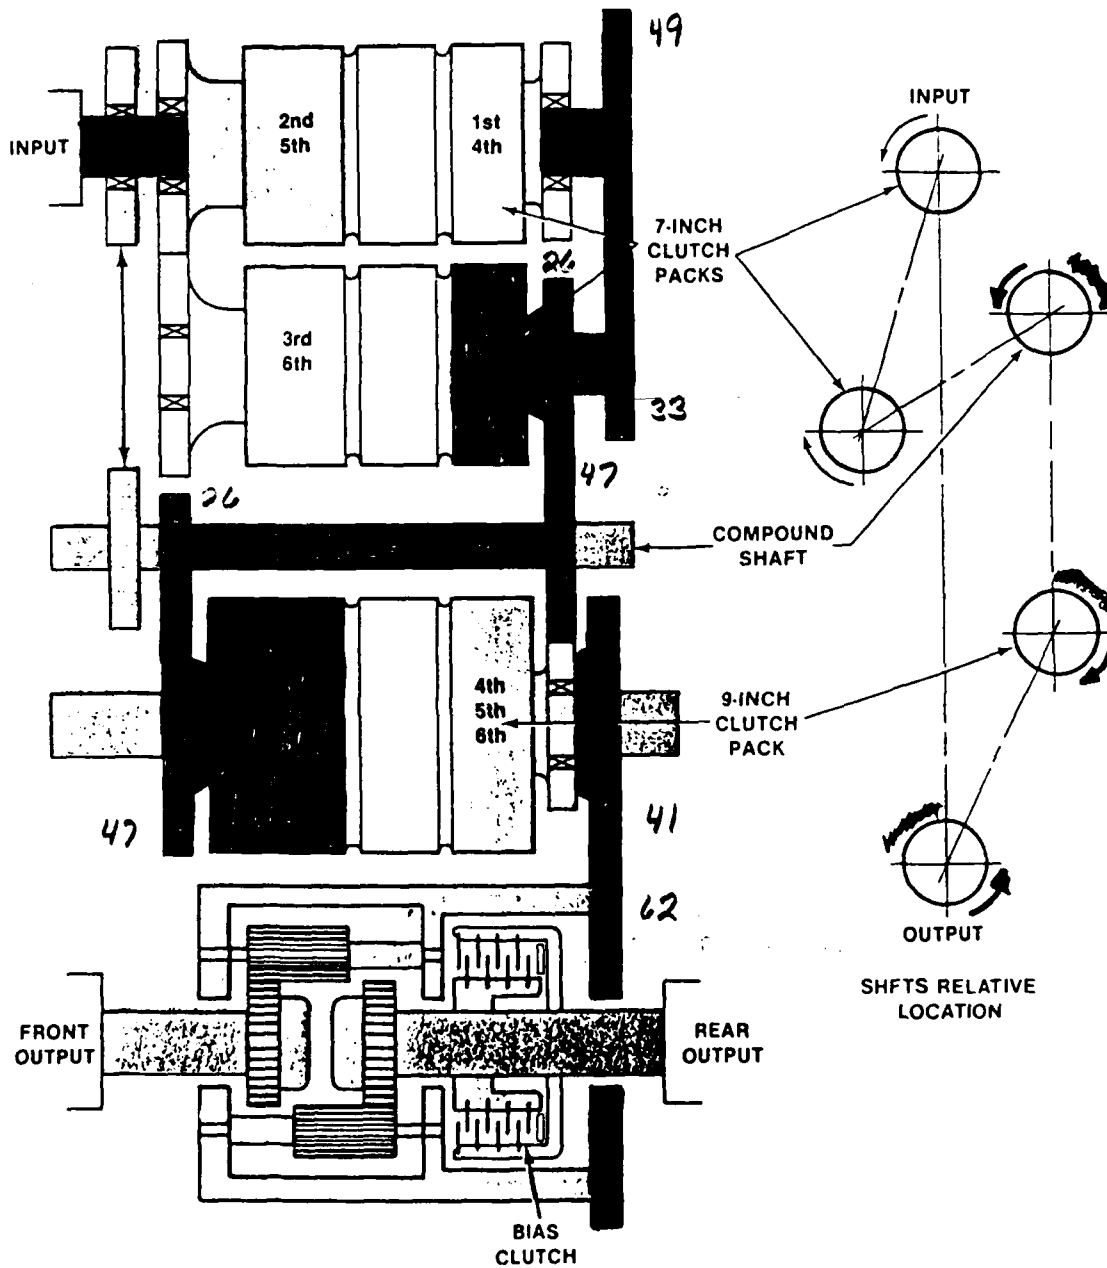
1 R

$$\text{TORQUE INCREASE RATIO} = \frac{33}{49} \times \frac{47}{26} \times \frac{47}{26} \times \frac{62}{41} = 3.328$$

$$\text{SPEED INCREASE RATIO} = \frac{49}{33} \times \frac{26}{47} \times \frac{26}{47} \times \frac{41}{62} = .300$$
